THE EFFECTS OF PITTING ON FATIGUE CRACK NUCLEATION
IN 7075-T6 ALUMINUM ALLOYLi Ma and David W. Hoepfner *
University of Utah
Salt Lake City, UT

SUMMARY

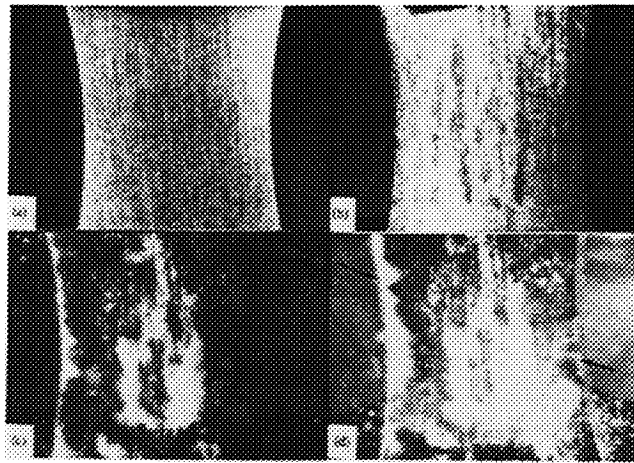
One characteristic feature observed during the testing was the formation of blisters. These blisters occurred on the surface and burst after remaining on the surface for a while. This observation supports the view regarding pit nucleation in aluminum offered by Barger and Givens.[4] They found that blistering occurred along the oxide/metal interface and resulted in breaking of the film because of high hydrogen gas pressure created in blisters, which therefore acted as precursors of pits.

Fig. 4. Video images of changes in surface states of the specimen in 3.5% NaCl, magnification 10.5X, (a) cycle, N=0, (b) cycles, N=68,900, (c) cycles, N=828,000, (d) cycles, N=3,082,000. Arrows indicate pits.

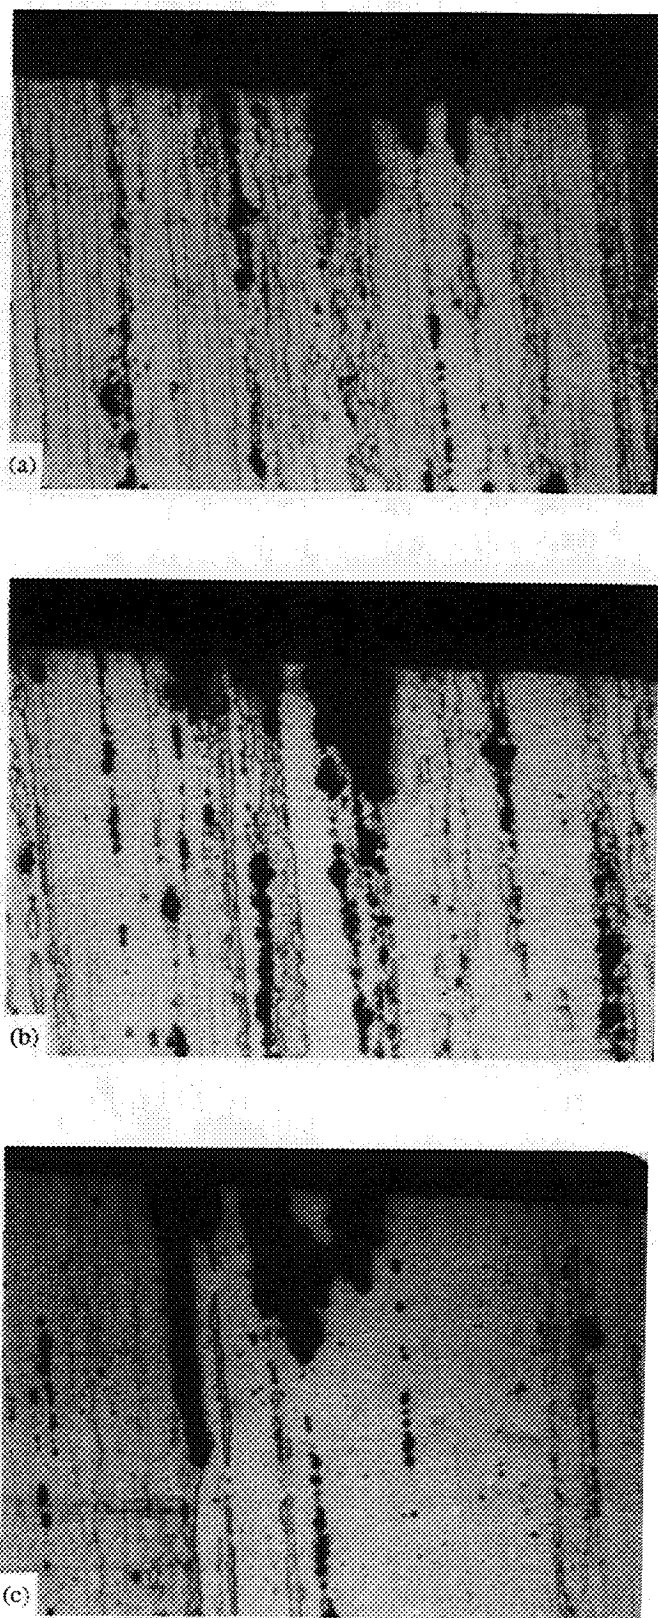
Profiles of adjacent cross sections of a tested specimen are shown in Fig. 6. To produce these adjacent cross sections, a vertical section was made through preselected pits and they were photographed. Then more material was removed from the specimen and the corrosion pits again were photographed. This process was repeated a third time. It is evident that the three pits shown in Fig. 6 (a) have coalesced. After removing a layer of metal from the pit cross section, it can be seen that the same pits were separate and had varied shapes and sizes, Fig. 6 (b). It is obvious that discrete pits nucleated at first, but that with increasing exposure time, pit coalescence took place to cause more extensive local attack. The same phenomenon was observed by Baker [6] when he studied the corrosion resistance of aluminum-magnesium-silicon alloy under a salt-spray condition.

According to ASTM standard G 46-76 (Standard practice for Examination and Evaluation of Pitting Corrosion), the pits shown in Fig. 6 (a) and (b) appear in the elliptical shape except for the smaller one in Fig. 6 which shows the narrow and deep shape. To evaluate the cross-sectional shapes of the same pits in more detail, another layer of the pit cross section was removed and the resulting pit shapes are shown in Fig. 6 (c). It is interesting to note that two pits joined together under the surface showing the undercutting shape with different depths, and other pits exhibited intergranular attack which originated from the base of the pit. Therefore, it can be concluded that a pit shape may vary irregularly when growing and it is difficult to determine the true maximum pit depth by the method of cross-sectioning the pit because the deepest pit may not have been selected and the pit may not be sectioned at the deepest point of the penetration. This observation provides evidence that modeling the pits will be an extremely complex process. Perchance on equivalent initial flaw size approach will be the best we can do. Modeling studies have been underway [1,2] by the first author and they are continuing under this program.

It also is noted that pit growth was strongly dependent on the orientation with respect to the rolling direction of the material as shown in Fig. 6. The same phenomenon was found in the other specimens. Fig. 8 presents the pits on the exposed surface of a different specimen. The picture shows that severe attack occurred along the fibrous grain orientation in the rolling direction.

Fig. 6. Cross section of pits in the specimen tested in 3.5% NaCl solution, magnification 400X (reproduced by 320 magnification), (a) after cross-sectioning, (b) after removing a layer of metal, (c) after removing the second layer of metal.

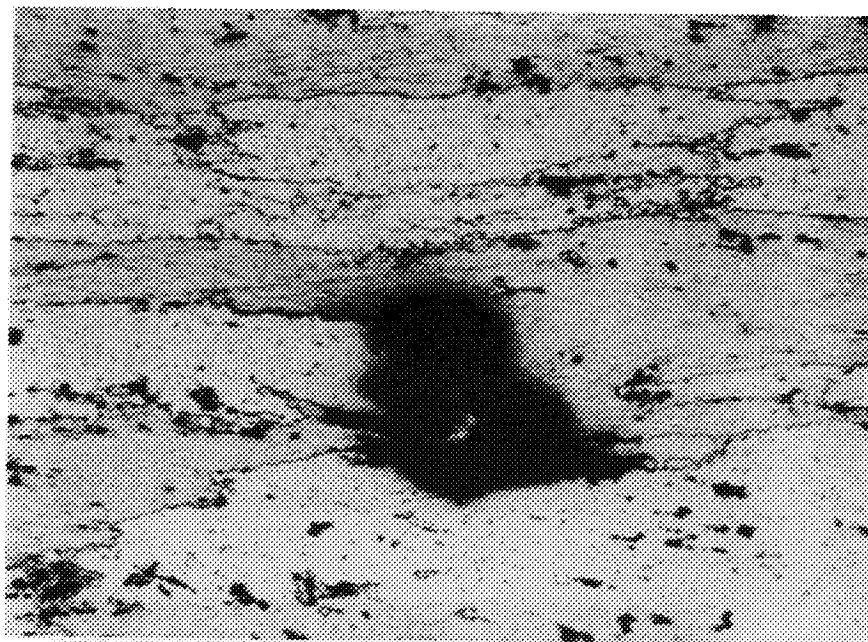
Further evidence of intergranular corrosion occurring along with the pit, in which case intergranular fissures advance into the metal laterally from the pit cavity, was identified on the exposed surface of another specimen after polishing and etching. Fig. 7 shows that the cracks which nucleated from the pit on the exposed surface of the specimen were caused by intergranular corrosion attack. In both cases (Figs. 6 (c) and 7) intergranular cracking originated from the pit. The reason for this might be that the electrochemical conditions in the pit readily lead to the occurrence of intergranular attack. According to Lifka,[7] in high-strength aluminum alloys the susceptibility to intergranular attack results from a localized decomposition of a solid solution at the grain boundaries and the formation of a precipitation in the vicinity of the grain boundaries. In the case of 7075-T6 aluminum, intergranular corrosion is probably related to the precipitation of the grain boundary phases, such as $MgZn_2$, which may themselves behave anodically with respect to the adjacent alloy. Hence, it is reasonable to believe that intergranular corrosion is another corrosion mechanism involved in crack nucleation in this research. Additionally, since the intergranular corrosion was found to penetrate deeply into the metal leaving behind little visible evidence of damage (Fig. 8), it is possible that intergranular corrosion may cause failure with extreme suddenness, especially when the materials are subjected to a lower fatigue stress level and a longer exposure time than in the present testing.

Fig. 7. Corrosion pit along with the intergranular corrosion cracks on the exposed surface of the specimen tested in 3.5% NaCl solution, magnification 200X. Arrows indicate the loading directions.

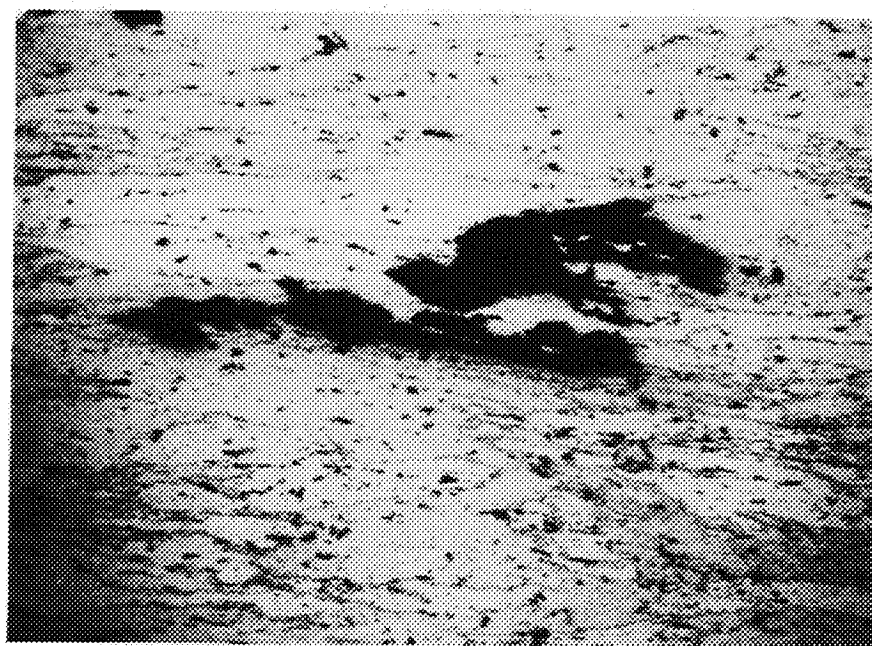
Fig. 8. Corrosion pits on the exposed surface of the specimen showing pit growth in the rolling direction, magnification 100X.

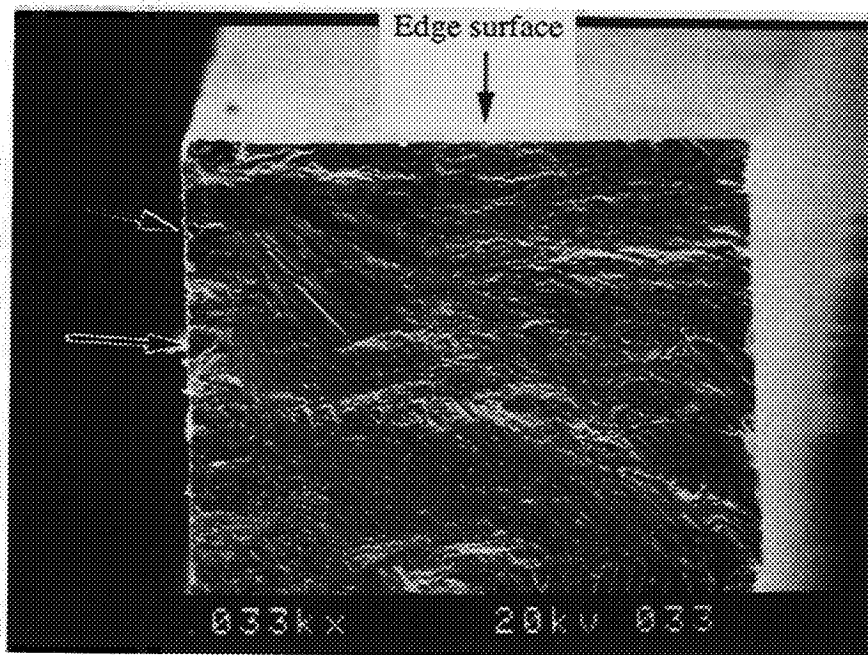
By tracing the radial track surface features shown in Fig. 9 it is evident that the fatigue cracks originated at the sites of corner corrosion pits. This observation confirms the assumption that the corrosion pits acted as stress concentration sites which resulted in nucleation of fatigue cracks. Careful examination around the crack nucleation areas showed that corner pits at the origin sites nucleated in the areas close to the corner of the edge surfaces which were covered with coating broken by solution penetrating during testing. The observations for the other specimens also indicated that the corner pits and pits close to the corners were preferential sites for fatigue crack nucleation. The reason for the evident preference for the crack to start at the corner pits or the pits close to the corners could be explained by the fact that the curved edges of the specimens were the most highly stressed areas compared to the other areas in the specimens. Finite element analysis confirmed this and is to be reported elsewhere. Some small pits also were found on the fracture surface, Fig. 9. However, it is obvious that crack nucleation was dominated by the large corner corrosion pit. It is recognized that in other cases the multiple damage sites (pits) away from the corners nucleate cracks that link up. This has been reported in other work by Hoepfner.[2]

One interesting phenomenon noticed was that the fatigue cracks seem to nucleate from the bottoms of the pits, Fig. 9. Some research [8] showed that a growing pit is a local electrochemical cell. The bottom of the pit is the anode and the surrounding walls of the pit and surface of the metal are the cathode. The fatigue crack nucleation occurred at the bottom of the corrosion pit, probably because this place is electrochemically active and the stress concentration is large enough to lead to the crack. Therefore, it is natural to conclude that corrosion fatigue nucleation is controlled by the rate at which pits nucleate and grow to a critical depth and shape. This interpretation must be tempered by the observation of intergranular cracking as discussed above.

Fig. 9. The crack nucleation area of the specimen tested in 3.5% NaCl solution showing the fracture origin at a corrosion pit. Arrows indicate the exposed surface and a small pit.

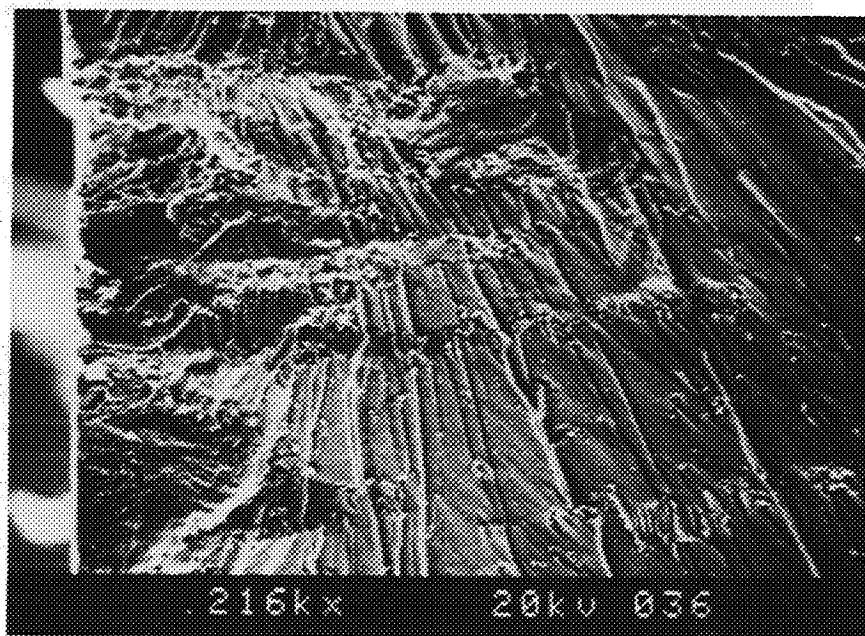
Most of the fracture surface was the fatigue crack propagation region where transgranular fracture was found to be the primary fracture path. Fig. 10 shows cleavage-like fracture, with river patterns emanating from the origin in the area adjacent to the fracture origin (see also Fig. 11). A small corrosion pit appeared on the surface, but no indication of the intergranular decohesion which would be the result of the intergranular corrosion was observed during the metallographic examination. Similar features were seen in

Fig. 10. Cleavage-like fracture near the crack origin of the same specimen showing in Fig. 9.

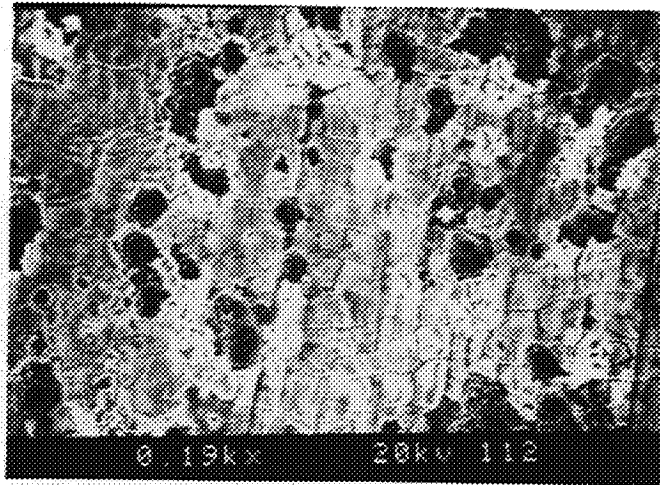
Numerous small and shallow cavities were observed on the exposed surface as shown in Fig. 13. These cavities were the result of the local breakdown of protective films and presumably attack at constituent particles and act as precursors of pits. Relatively large and deep corrosion pits also were found on the exposed surfaces of the specimens. These pits were distributed randomly on the exposed surfaces and appeared in different shapes and sizes. Figs. 14 and 15 show the appearance of pits observed in one specimen. It was interesting to notice that these pits had different shapes on the same exposed surface. Fig. 14 shows a typical hemispherical pit located at near center of the exposed surface. A group of pits was found on the same exposed surface as shown in Fig. 15, which exhibits multi-site damage (MSD) related to corrosion pitting. This group of the pits showed coalescence of pits giving rise to more local attack, and these pits appeared in irregular shapes. Numerous pits in a group also were observed in the other specimen as shown in Fig. 16. Pits in this group grew along the orientation with respect to the rolling direction of the material. All the pits were three dimensional in nature. The shapes of the corrosion pits might influence the fatigue life in different degrees, since the magnitude of the stress concentrations depends on the pit shape and geometry dimensions.

Fig. 13. Small cavities on the exposed surface of the specimen tested in 3.5% NaCl solution (cycles to failure are 4,822,200).

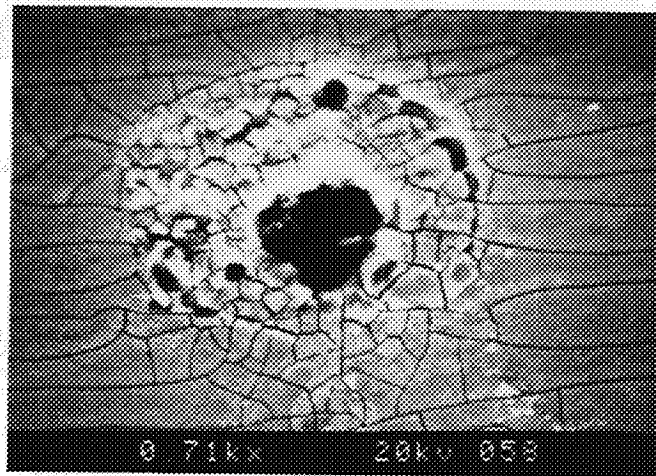
Fig. 14. Hemispherical shape of pit on the exposed surface of the specimen tested in 3.5% NaCl solution (cycles to failure are 3,279,300).

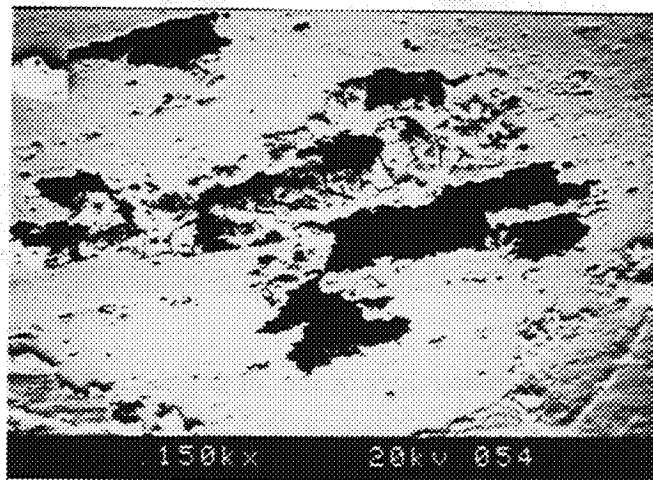
Fig. 15. Group of pits on the same specimen showing in Fig. 14.

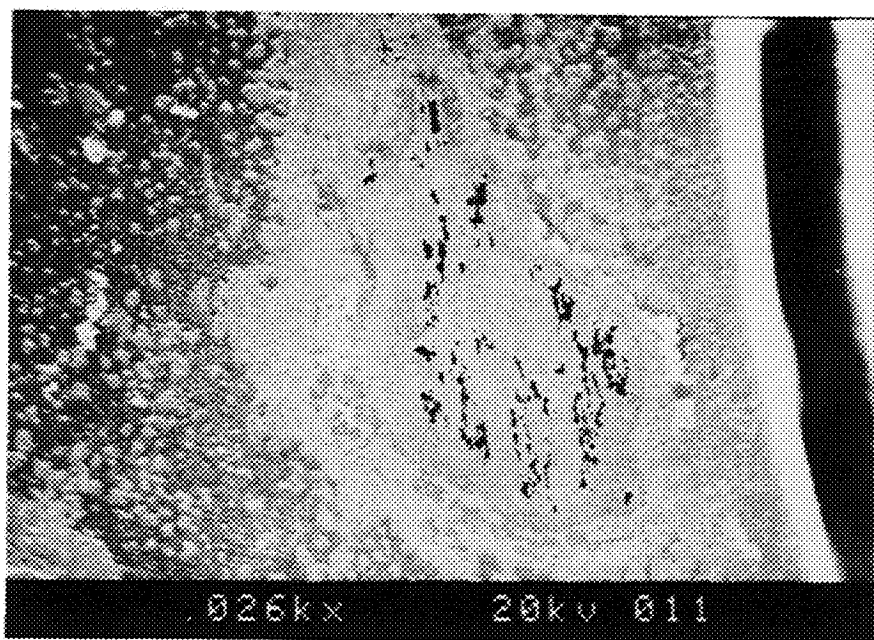
Fig. 16. Pits appear in a group in the specimen tested in 3.5% NaCl solution.
